To:	Dick Butler, Aanderaa Instruments
From:	Marinna Martini
Date:	June 2 nd , 2003
Subject:	Oxygen sensor beta test, deployment #2, report of results and observations

I have completed processing the data from the second beta deployment of the Aanderaa oxygen optode at the MWRA/USGS long term mooring site in Massachusetts Bay. This deployment had a few problems, not with the Aanderaa instrumentation, but with the recovery and comparative data.

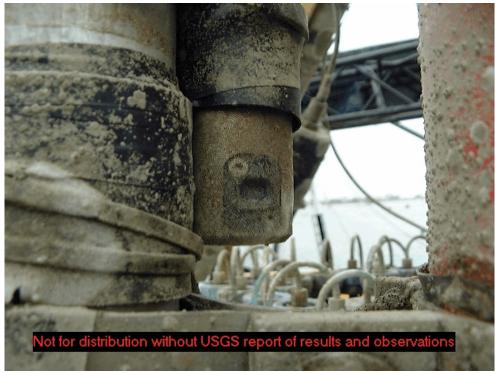
1) The entire surface of the optode, including the window, was completely coated with a fine layer of fouling, shown in Figures 2 and 3. It is unclear when this fouling started.

Figure 2: Biofouling on the Aanderaa optode shown as recovered.

- 2) According to observations at the GOMOOS site, the spring bloom starts at the end of March.
- 3) Other than biofouling, there do not appear to be any issues with the data.
- 4) The organism covering the optode in Figures 2 and 3 is a colonial encrusting bryozoan, which does consume oxygen and it is unclear how much oxygen can pass through their exoskeletons. Figure 3 shows them to have effectively covered and sealed the entire surface of the optode window.
- 5) On the March 30th deployment cruise, a Winkler titration was performed on a water sample taken 2 mab at 42-22.540N, 070-47.145W, a position 273 m bearing 197°T from the optode location. Three repetitions on a single sample resulted in an oxygen concentration of 12 mg/l at the same time the optode measured 10 mg/l.

An optode is currently deployed for the period of March through September 2003 attached to an RCM logger. It has a copper ring around the window, but no antifouling on the window itself. A Seabird sensor is not deployed at this time.

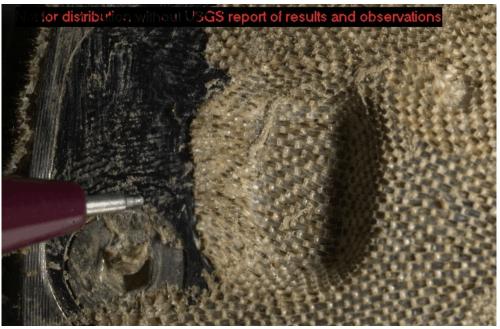
Figure 3: Closeup of biofouling on the Aanderaa optode, some of the organisms were removed when the sensor was dismounted from the tripod.
